FLUTTER TESTS OF B-34 FIN-RUDDER-TAB SYSTEM

By Theodore Theodorsen and N. H. Smith

MEMORANDUM REPORT

Army Air Forces, Materiel Command

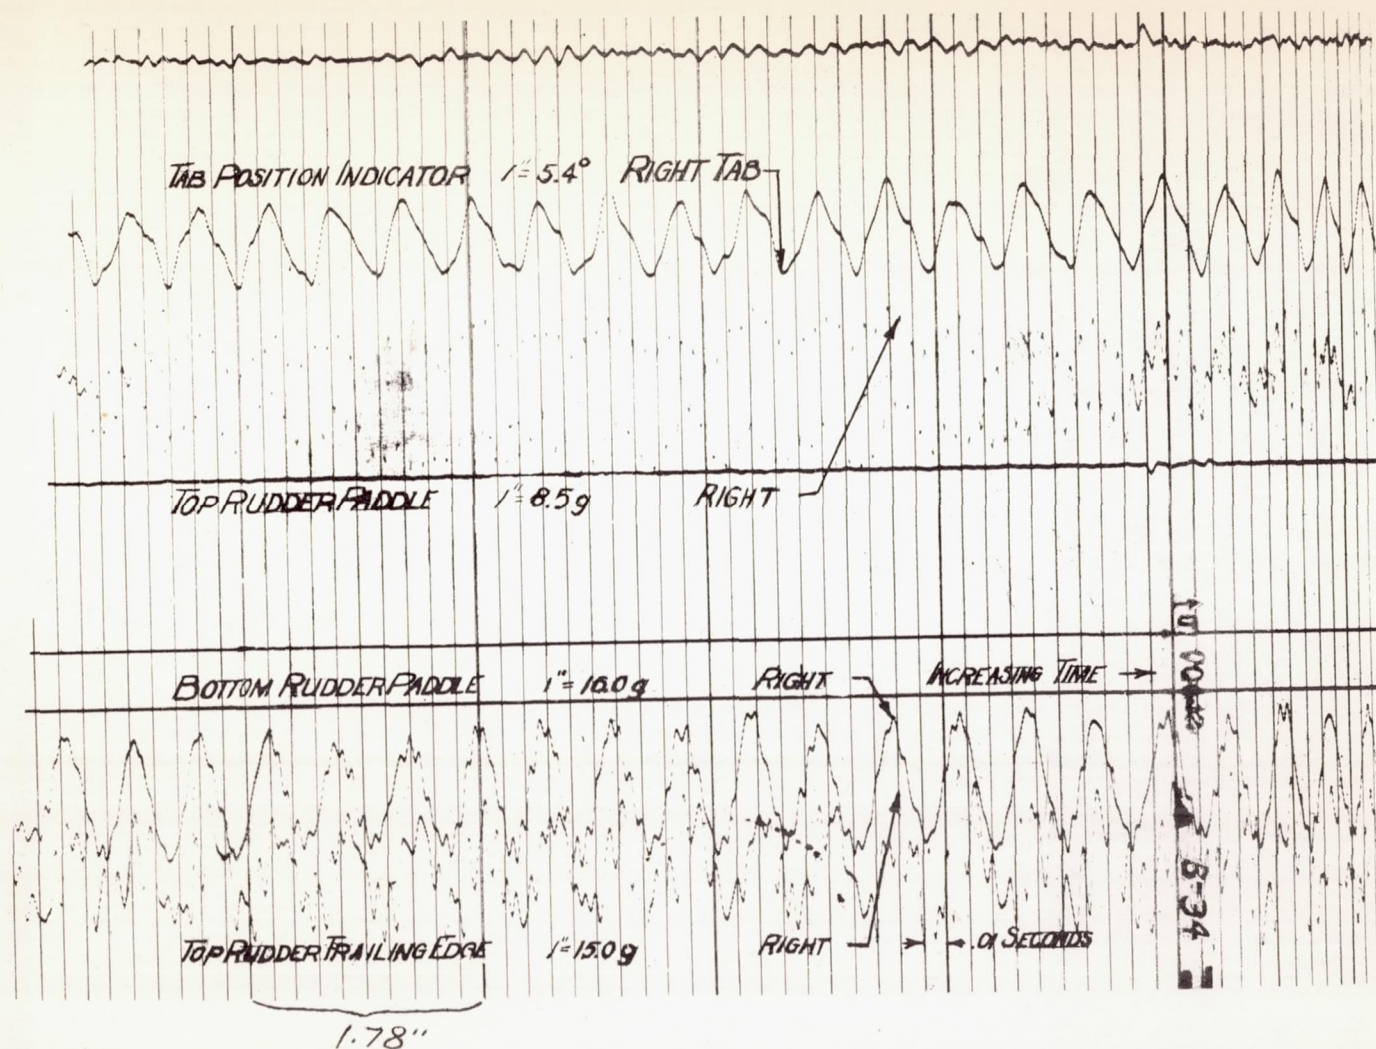
For condition (2), the amount of tab play was increased to  $1.05^\circ$  by machining one of the tab push-rod bearing bolts to a smaller diameter than standard. Tunnel velocities were again increased until a velocity of 354 miles per hour was reached without flutter. The oscillograph records show tab motion of small amplitude, however, at a frequency of 34 cycles per second. Amplitudes from these records are plotted in figure 6. A typical oscillograph record obtained from tests made under condition (2) is shown in figure 8. This test was discontinued because it was feared that the flutter would be severe, as the earlier tunnel velocity (for condition (1)) had been exceeded by a considerable amount.

Figure 8.- Typical oscillograph record showing mild flutter. Tab play,  $1.05^\circ$ ;  $V = 344$  mph;  
 $M = 0.440$ ; tab frequency, 32.5 cps.
